### 8.2.2.5 Link 5: Milborough Line from Campbellville Road to Concession 11 E

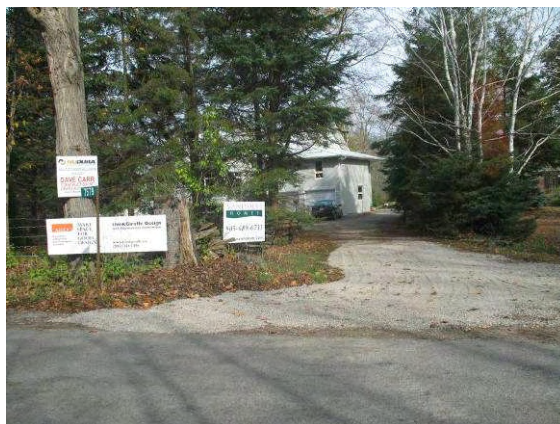
Photo 8 - 23: Sample driveway along Milborough Line

**Disadvantages:** Along this link, there is an on-street suggested bike route that passes approximately 23 residential driveways. On weekdays, approximately 11 school buses use this link daily. There is an ESA and a business. As visibility on the link is substandard, reconstruction and widening will be required.

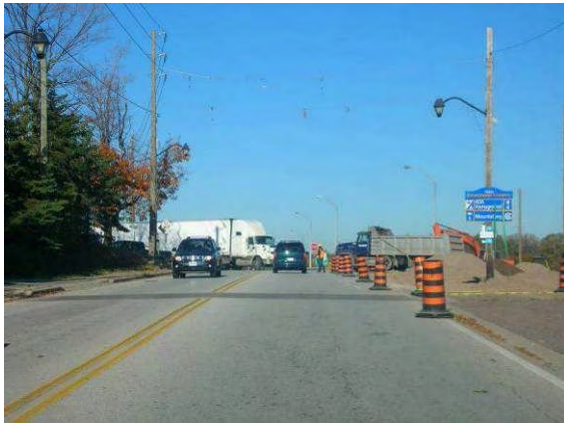
**Photo 8 - 25: Guelph Line, near construction zone at Highway 401 Interchange**

**Disadvantages:** This link does not provide access to Highway 401 without passing through the business heart of the Campbellville community. Additional truck traffic passing through Campbellville may create conflicts with vehicular traffic and pedestrians. On Guelph Line, just south of Campbellville, there is a rail crossing controlled by lights and gates.

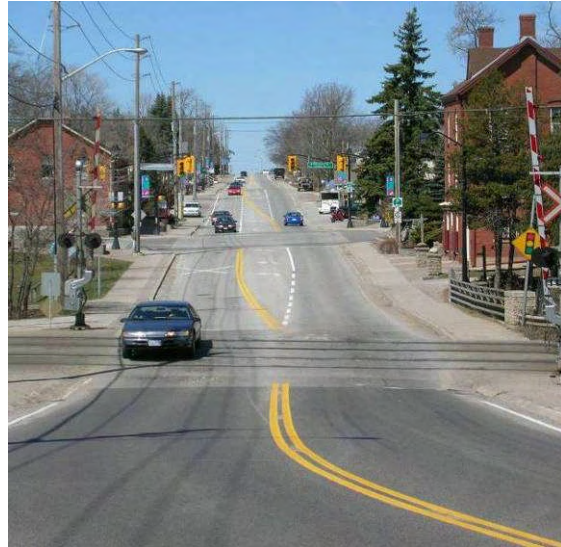
**Photo 8 - 26: Guelph Line at the heart of Campbellville**

The geometric conditions at the intersection of Guelph Line and Campbellville Road are not conducive to expansion. It is not advisable to increase the truck traffic, particularly truck traffic turning left off Campbellville Road to go north, or coming south and turning right,.
